Monitoring Completed Navigation Projects Program

Lock Wall Expedient Repair Demonstration Monitoring, John T. Myers Locks and Dam, Ohio River

October 2011

Final report

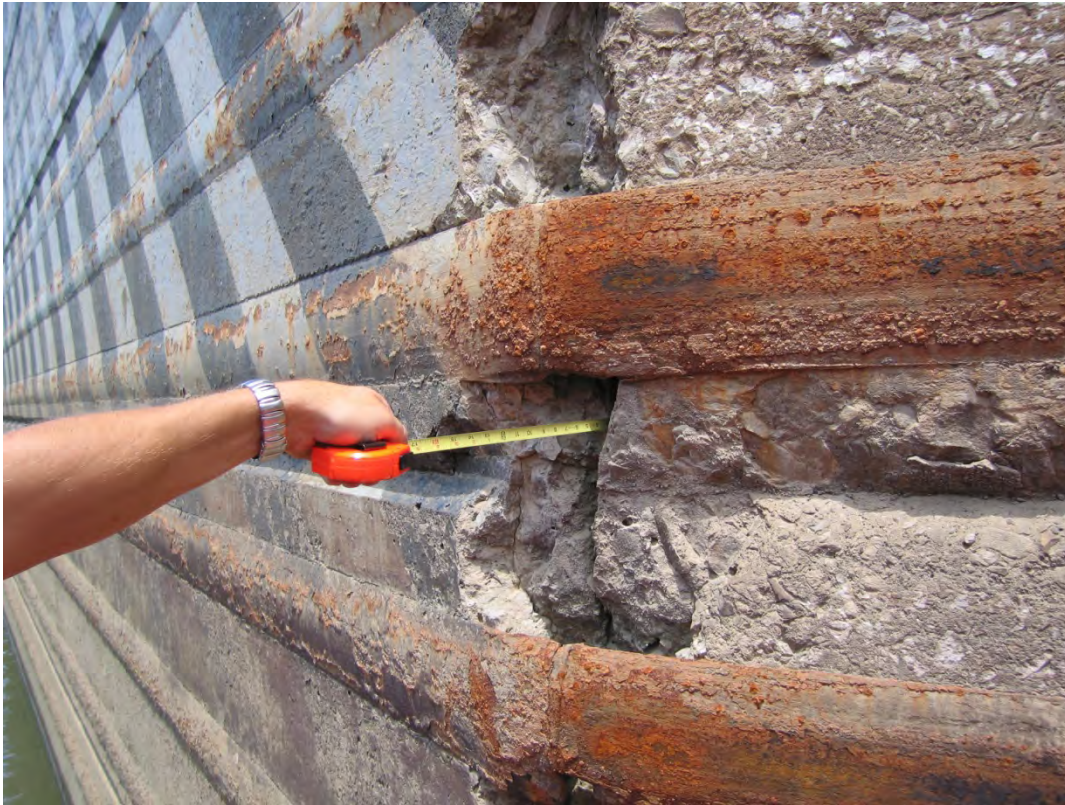
The lock chambers at John T. Myers Locks and Dam are very susceptible to wall damage due to the large amount of traffic passing through these locks. Approximately 75 million tons of commodities are shipped through these locks annually. Consequently, the wall armor system exhibits a large amount of damage. The majority of the damage includes gouges and spalls in the concrete adjacent to an armor strip. Many of the gouges are next to a vertical joint (Figure 2). In addition to the spalls and gouges, wall armor separation exists at several locations (Figure 3).

Figure 2. Concrete spalling at vertical joint, John T. Myers Locks and Dam.

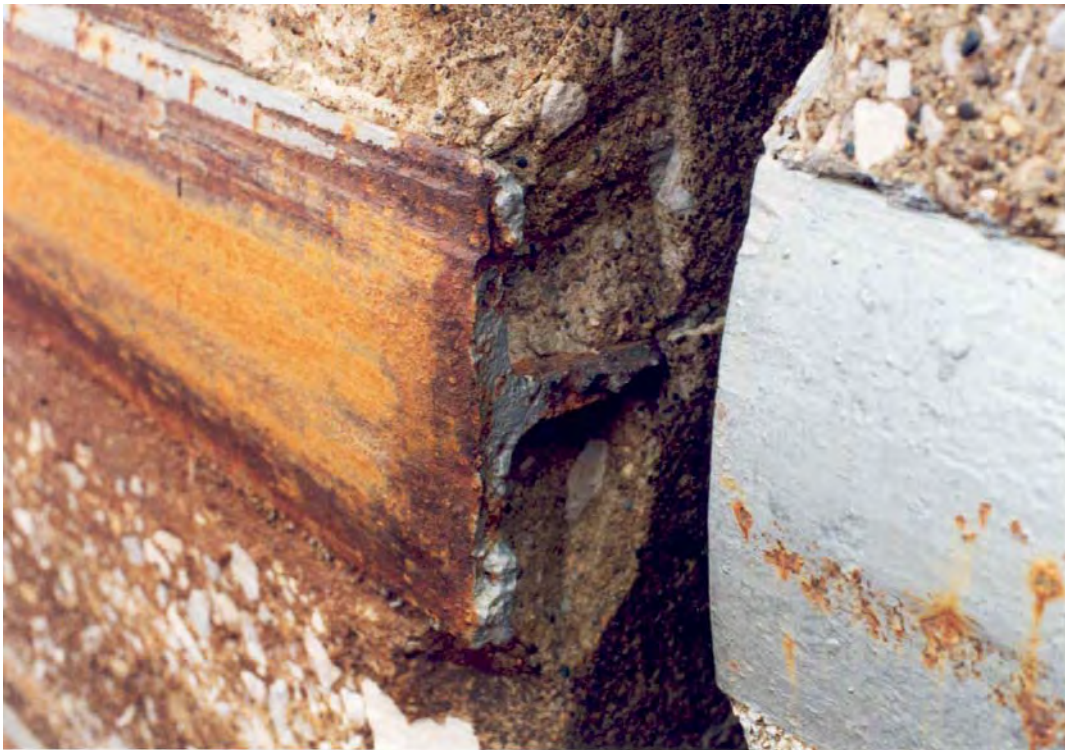
Figure 3. Wall armor separation, John T. Myers Locks and Dam.

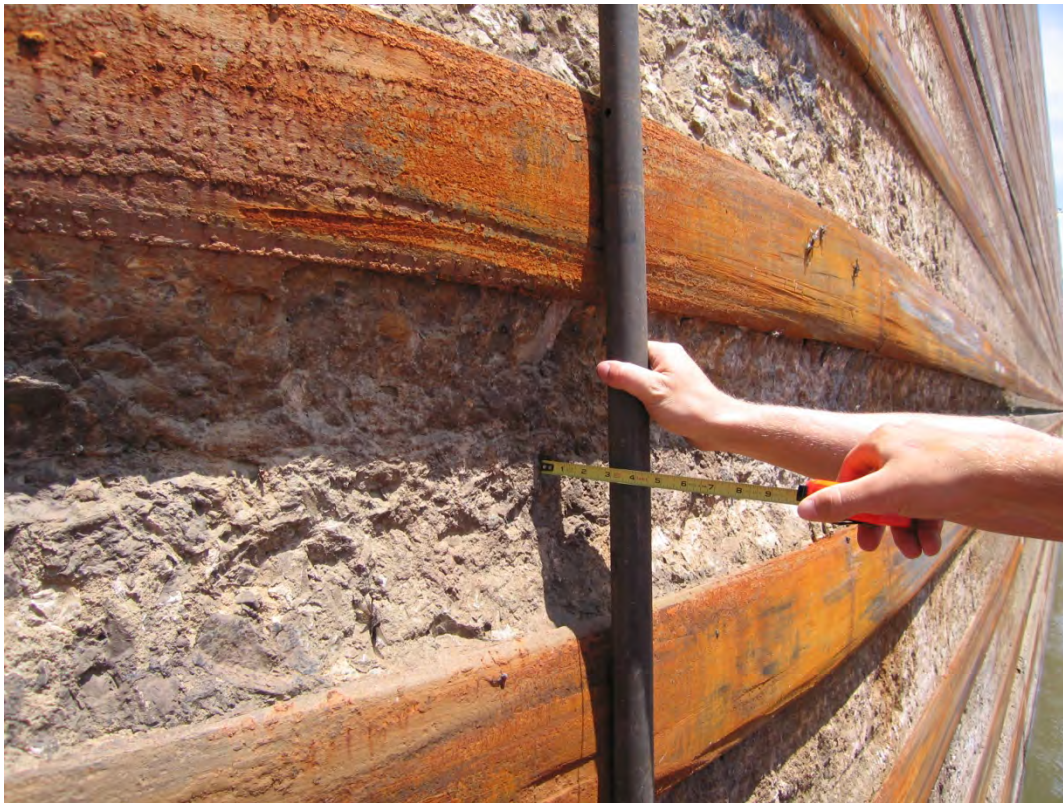
The most common type of armor-related damage is the loss of concrete (Figure 4). This type of damage can lead to more serious problems such as broken armor strips, since the concrete provides stability and stiffness to the steel systems. Additionally, gouges in the concrete can cause severe discontinuities in the lock wall surface. These discontinuities often result in protruding armor. If a barge or other vessel strikes these protruding edges in such a manner as to engage the armor itself, serious damage could occur to the vessel, the lock wall, or both.

Figure 4. Loss of concrete between armor strips, John T. Myers Locks and Dam.

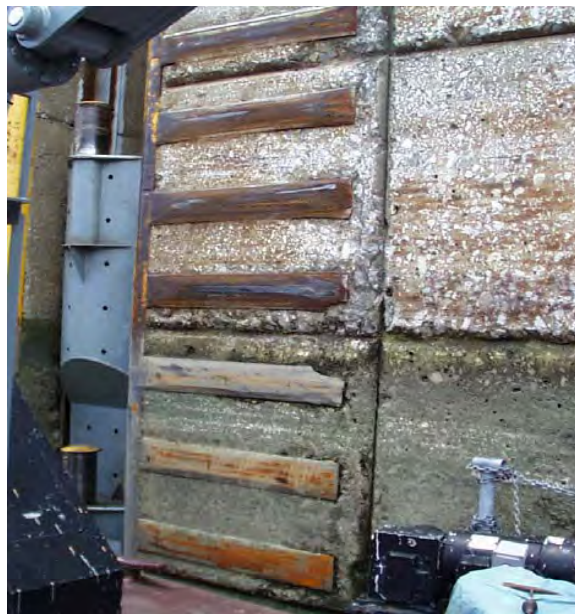
terminated near a monolith joint. Examples of this type of damage are shown in Figures 8 - 10. The relatively small concrete section between the end of the armor and the monolith joint is inadequate to resist the impact loads transmitted through the armor. Apparent bending of the armor beyond the last anchor also appears to contribute to localized crushing and subsequent loss of concrete section (Figure 9). Significant loss of concrete (Figure 10) makes these areas more susceptible to damage during chamber filling and emptying, particularly where barges have protruding steel plates such as shown in Figure 11.

Figure 8. Overall view of Type I damage, John T. Myers.

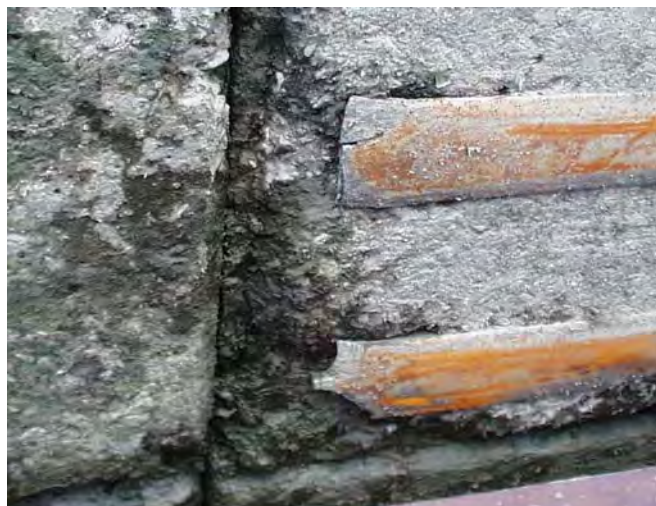
Figure 9. Type I armor fractures and concrete spalling, John T. Myers.

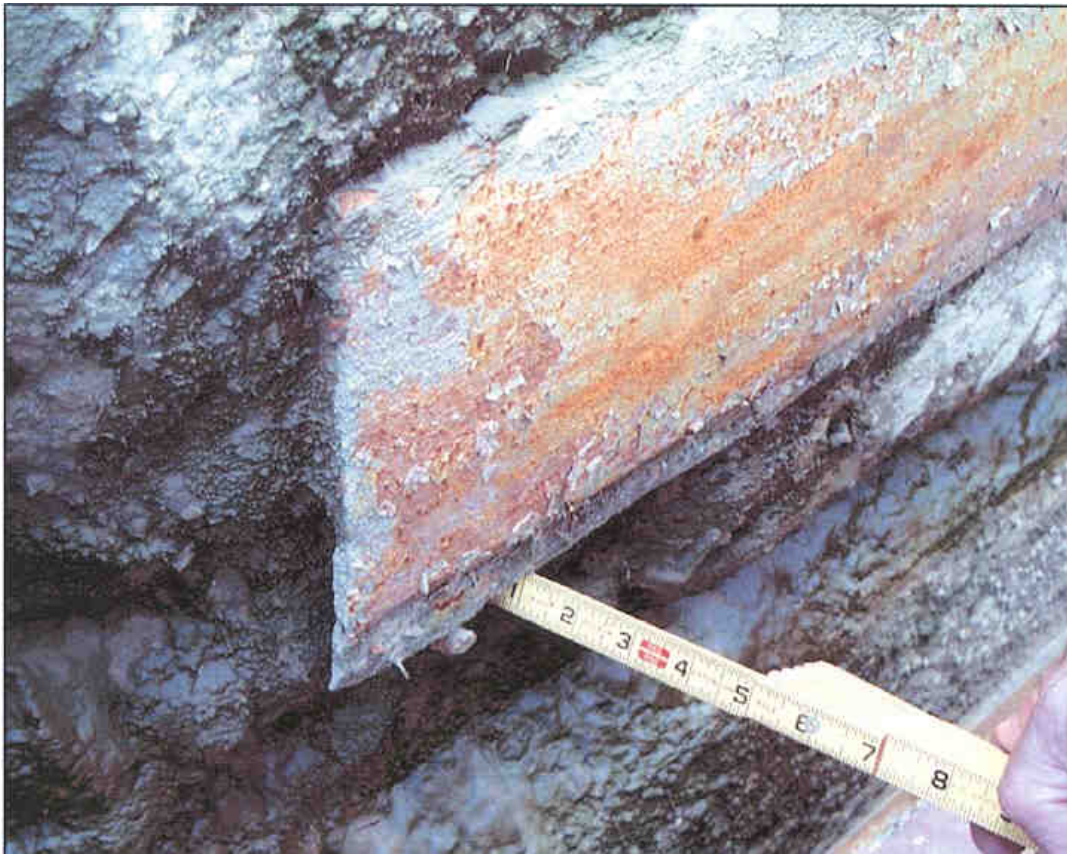
Figure 10. Type I loss of concrete section, John T. Myers.

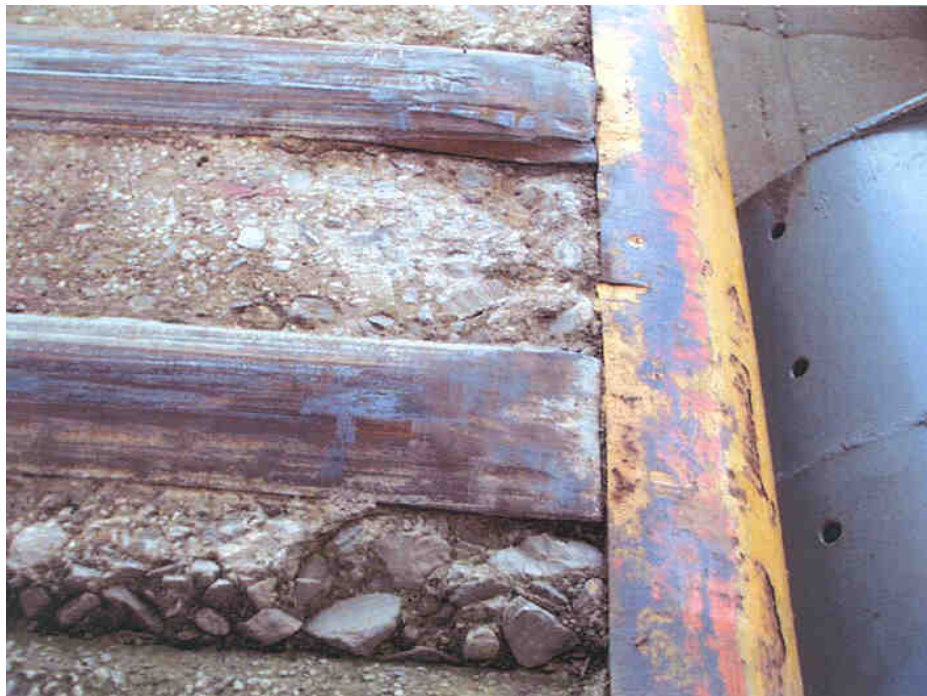
impact and abrasion (Figure 23). However, this protection was compromised in some cases because the wall armor was flattened by barge abrasion (Figures 24 and 25). Continued loss of wall armor section combined with loss of concrete section (Figure 26) will exacerbate this type of damage with potentially serious consequences for lock operations.

Figure 23. Typical Type II damage, John T. Myers, localized crushing of concrete.

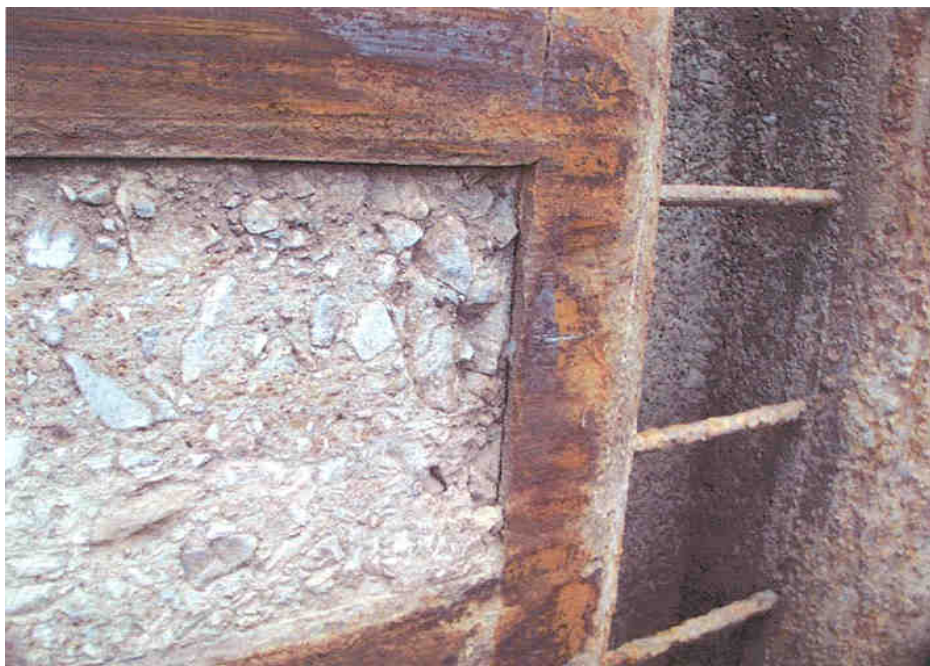
Figure 24. Typical Type II damage, John T. Myers, impact abrasion.

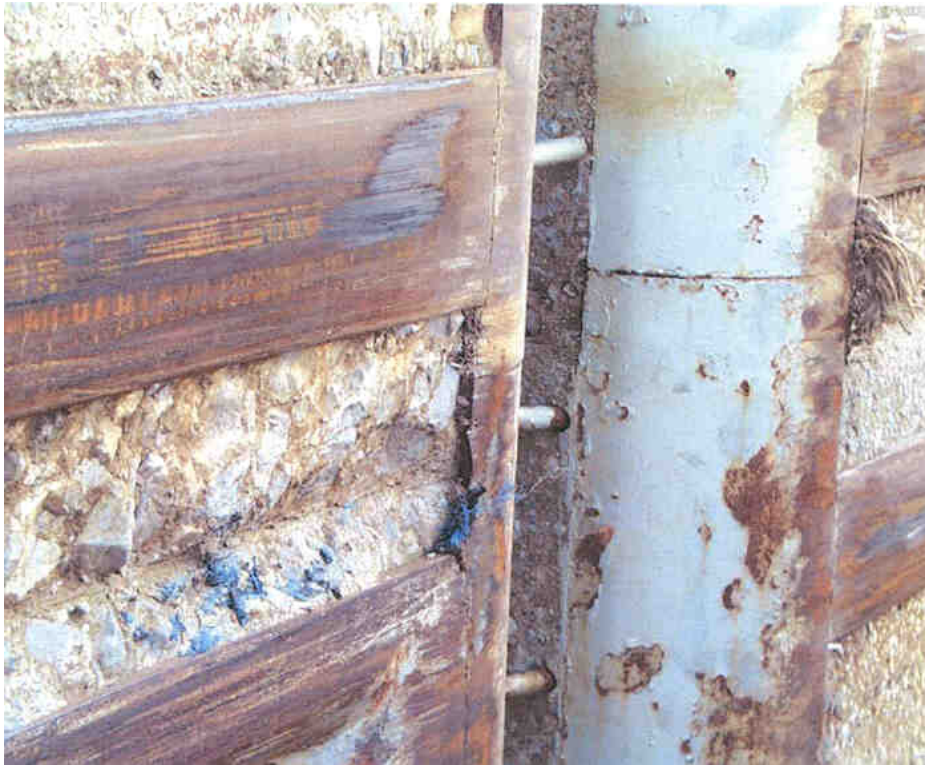
Figure 25. Typical Type II damage, John T. Myers, barge abrasion.

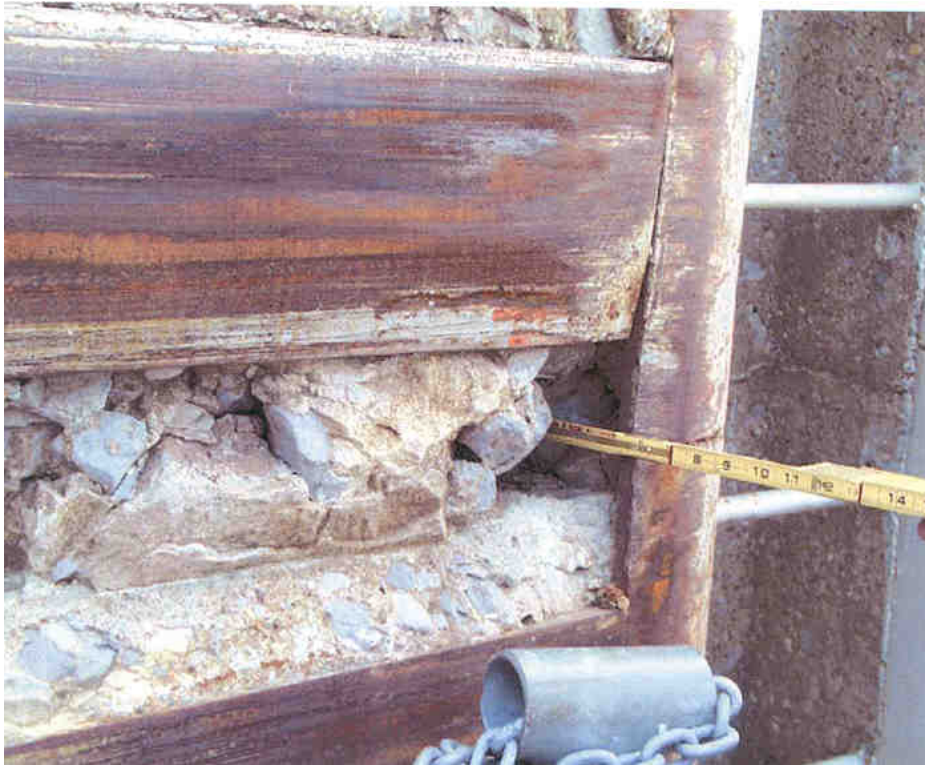
Figure 26. Typical Type II damage, John T. Myers, loss of concrete section.

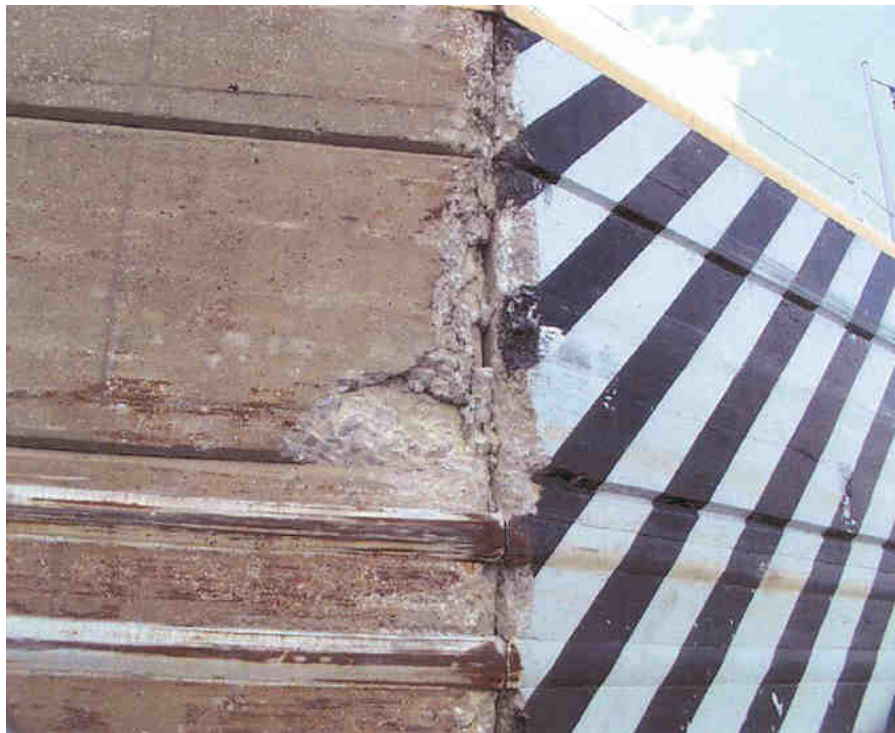
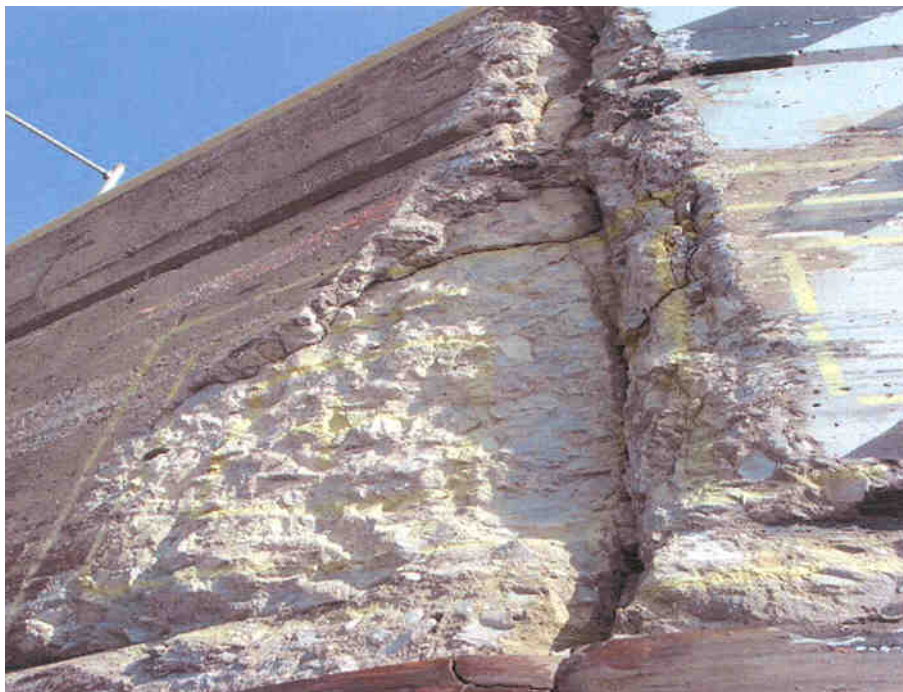
Figure 27(a). Example of Type III damage, John T. Myers, 1999 (continued).

Figure 27(b). Example of Type III damage, John T. Myers, 1999 (concluded).

The wall armor system in this area performs reasonably well; therefore, any necessary repairs of localized damage should focus on restoring the joint to its original condition. Complete confinement of the concrete within the armor appears to provide good resistance to impact and abrasion (Figure 29).

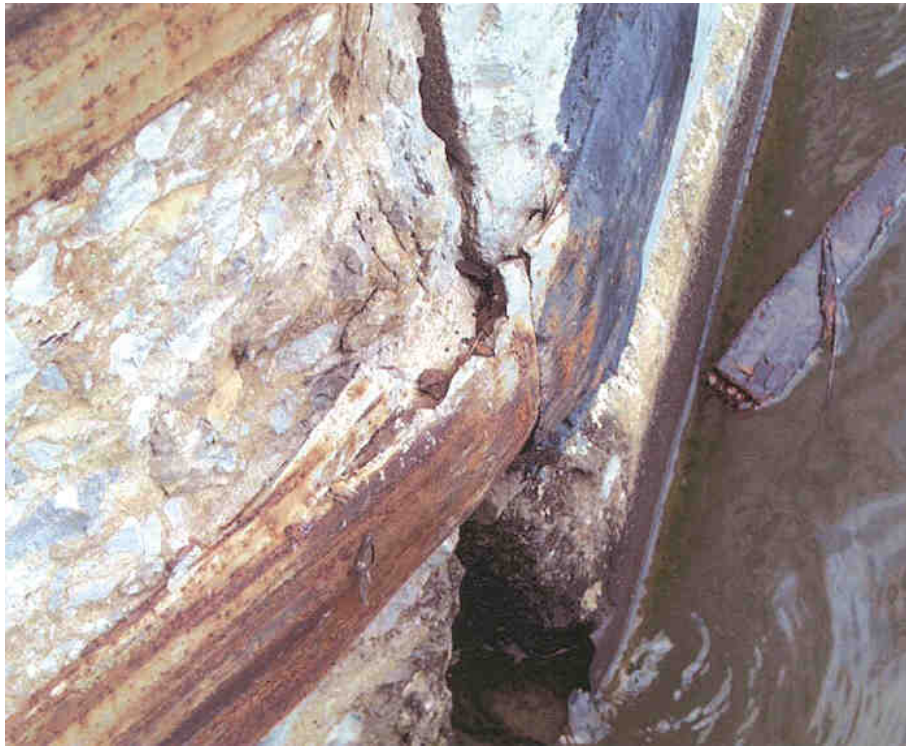
Figure 28. Typical Type III damage, John T. Myers.

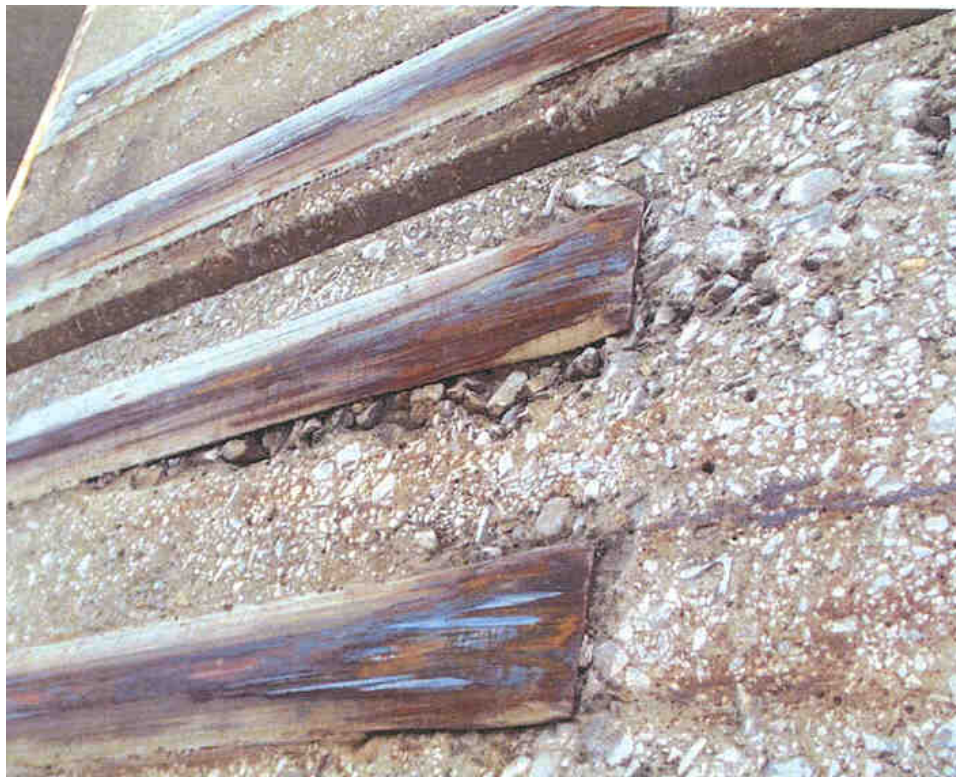
Figure 30. Typical Type IV damage, John T. Myers, end of armor section.

The wall armor system in this area performs well; therefore, repair of the localized damage does not appear necessary at this time. These areas should be monitored periodically because continuing loss of section caused by abrasion will increase armor flexibility that can, in turn, result in increased concrete damage and make the armor itself more susceptible to damage.

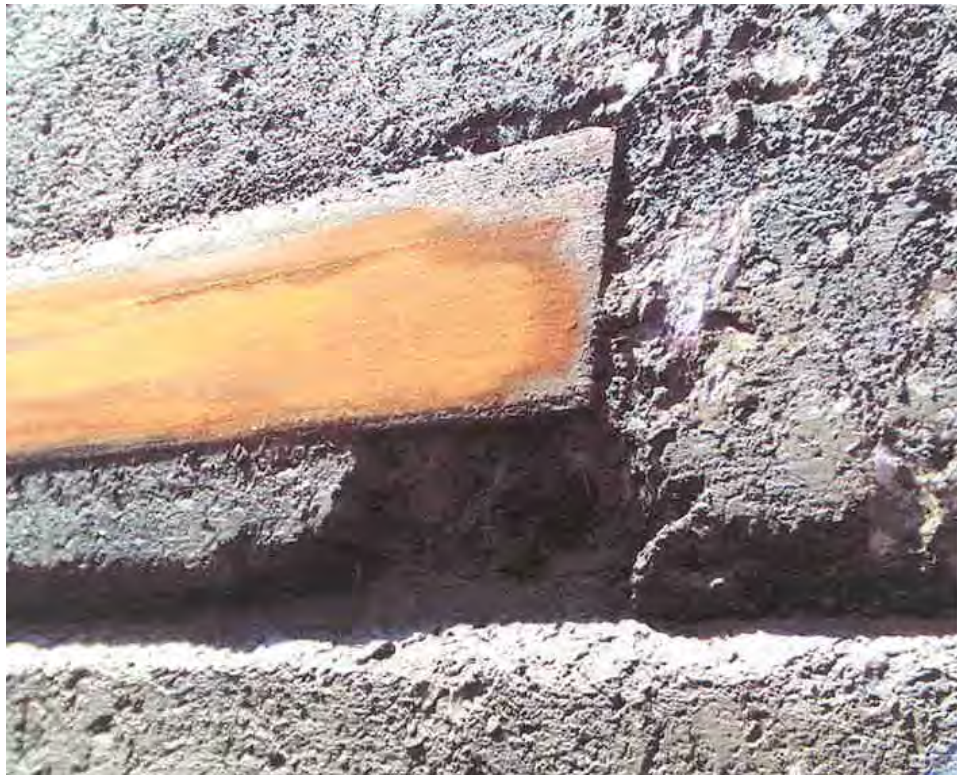
Figure 31. Typical Type IV damage, John T. Myers, armor near lift joint.

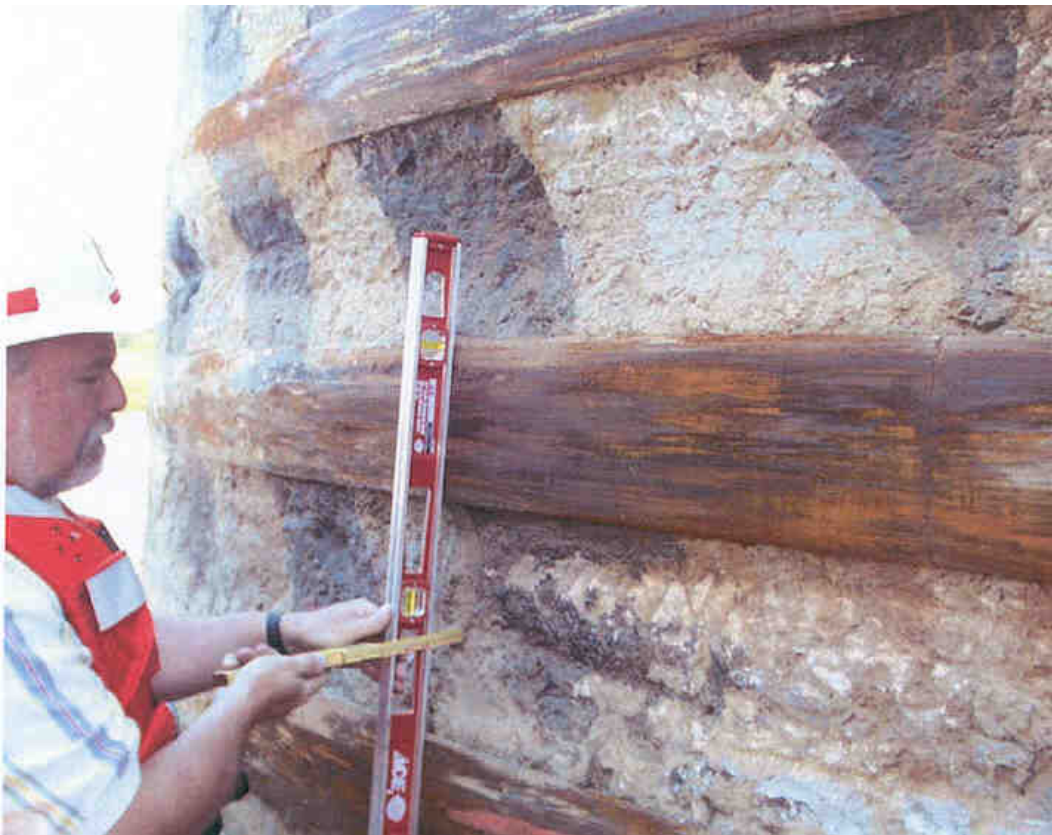
During the 1999 survey, CELRL personnel stated that the consequences of a catastrophic event such as barge sinking were not as dire in the area of a bullnose as they would be inside the lock chamber; therefore, problems within the lock chamber should be addressed first. Therefore, the need for repair of bullnose damage at this time is questioned. These areas should be monitored periodically to determine the rate of concrete abrasion because continuing loss of section could ultimately affect the armor anchor system. Also, continued abrasion could undermine the edges of the wall armor,

Figure 32. Typical Type V damage, John T. Myers, bullnose.

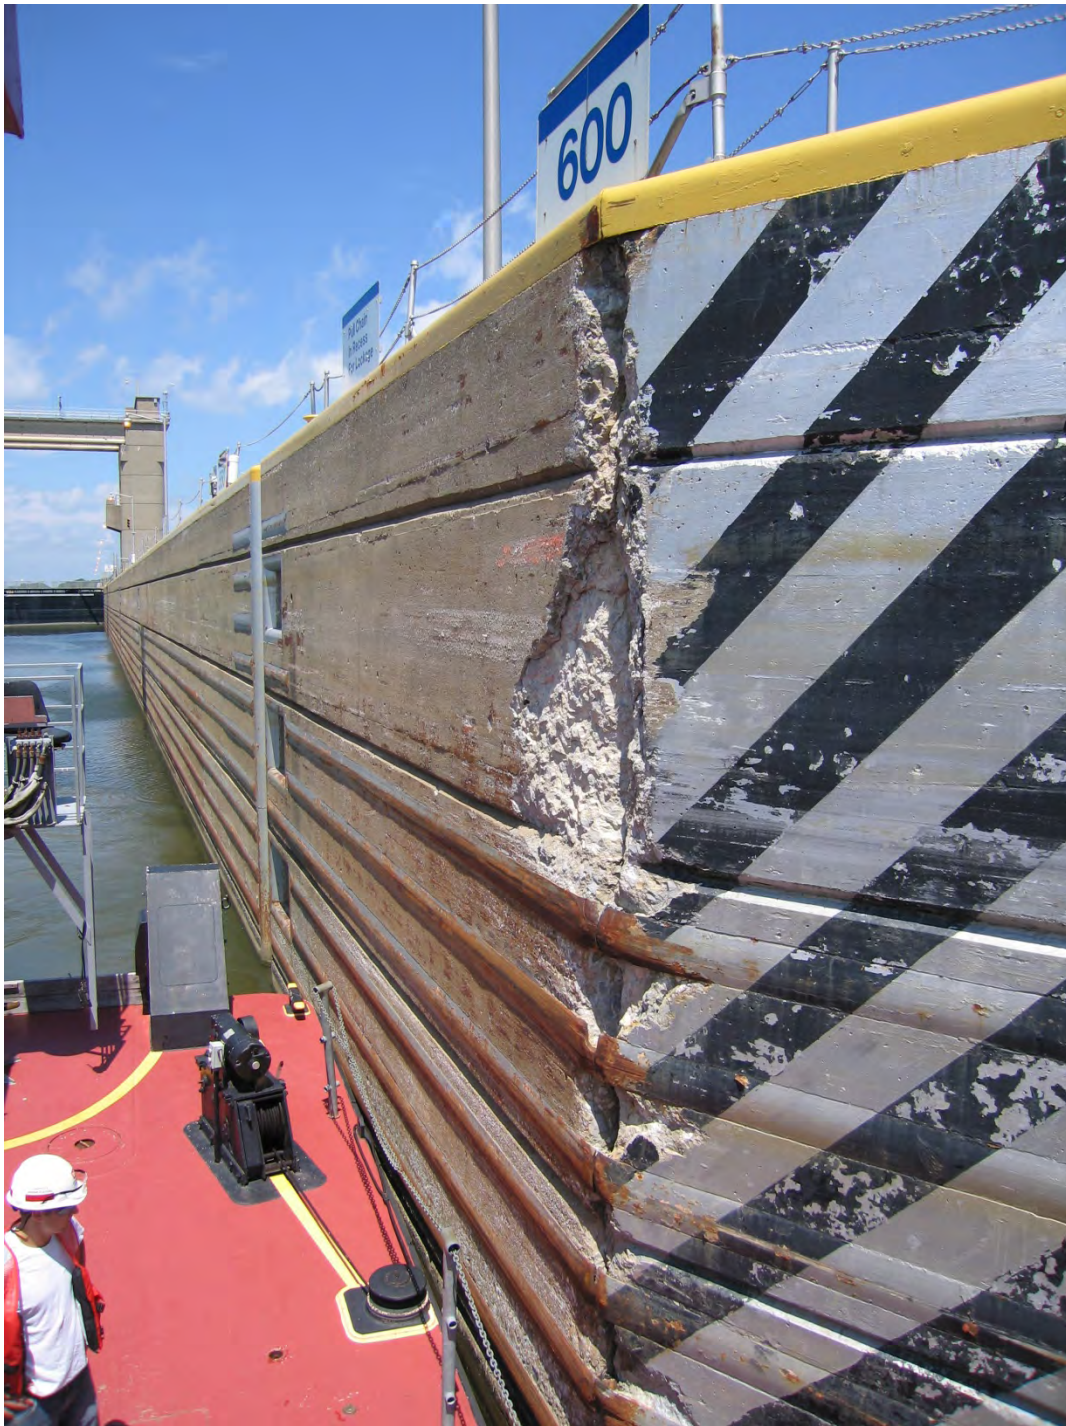
where the bullnose intersects the 600-ft chamber upper land-wall is shown in Figure 38. Close-up photos of the most damaged portion of concrete are shown in Figures 39 and 40.

Figure 38. Damaged vertical joint of 600-ft chamber upper land-wall approach to be repaired.

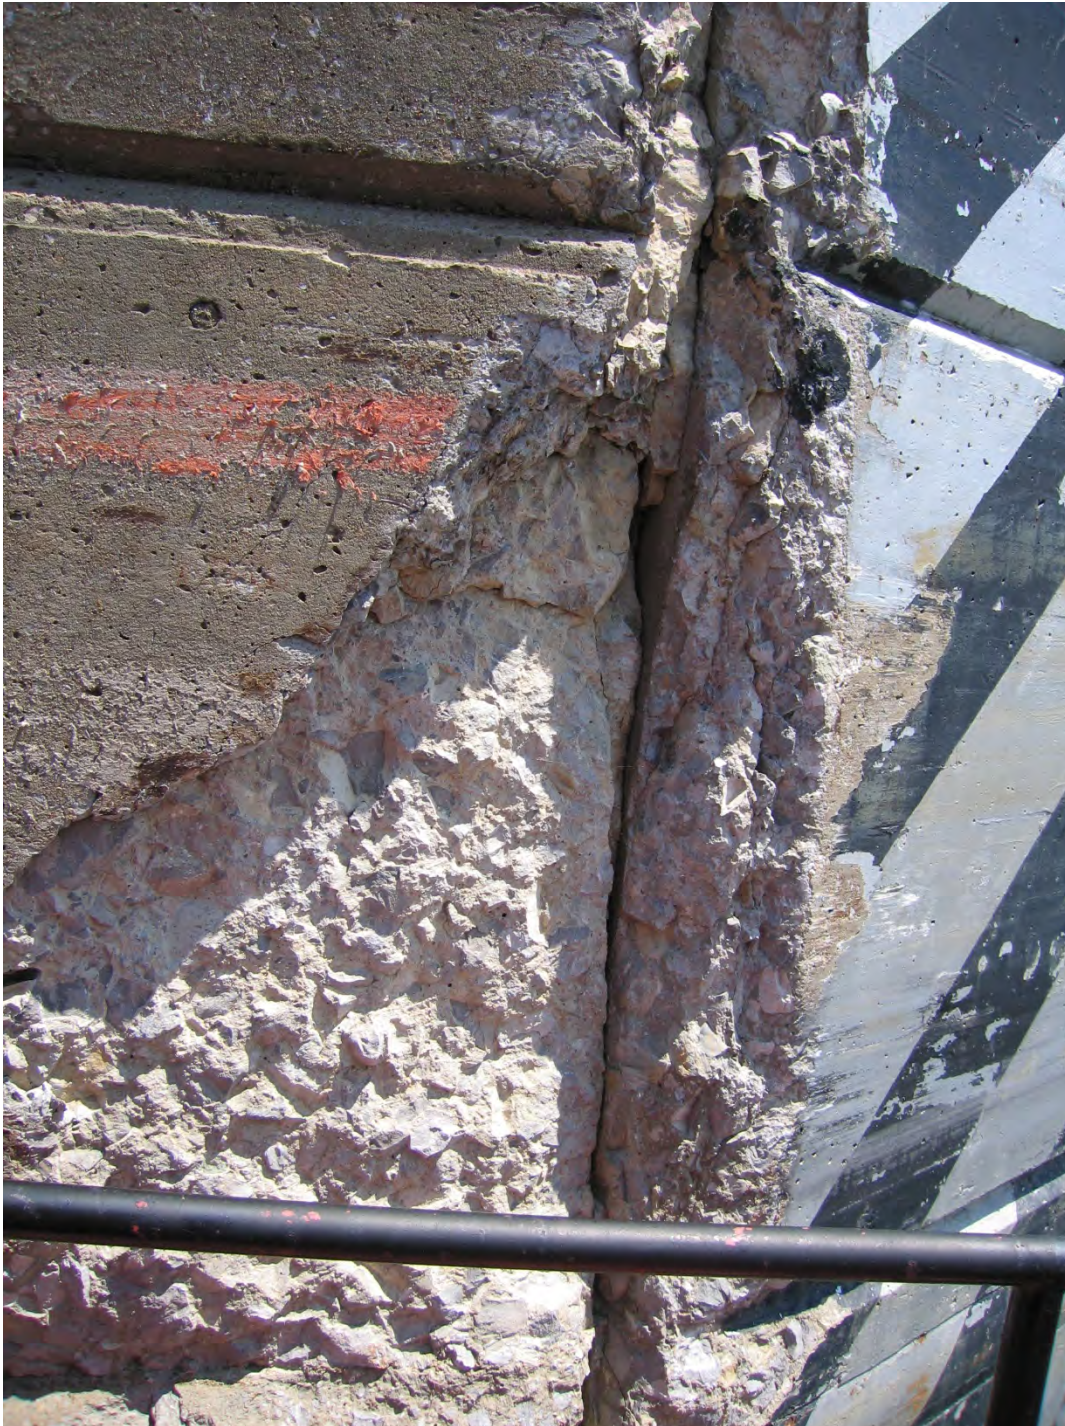
Figure 39. Closeup photo of major concrete damage at the vertical joint to be repaired.

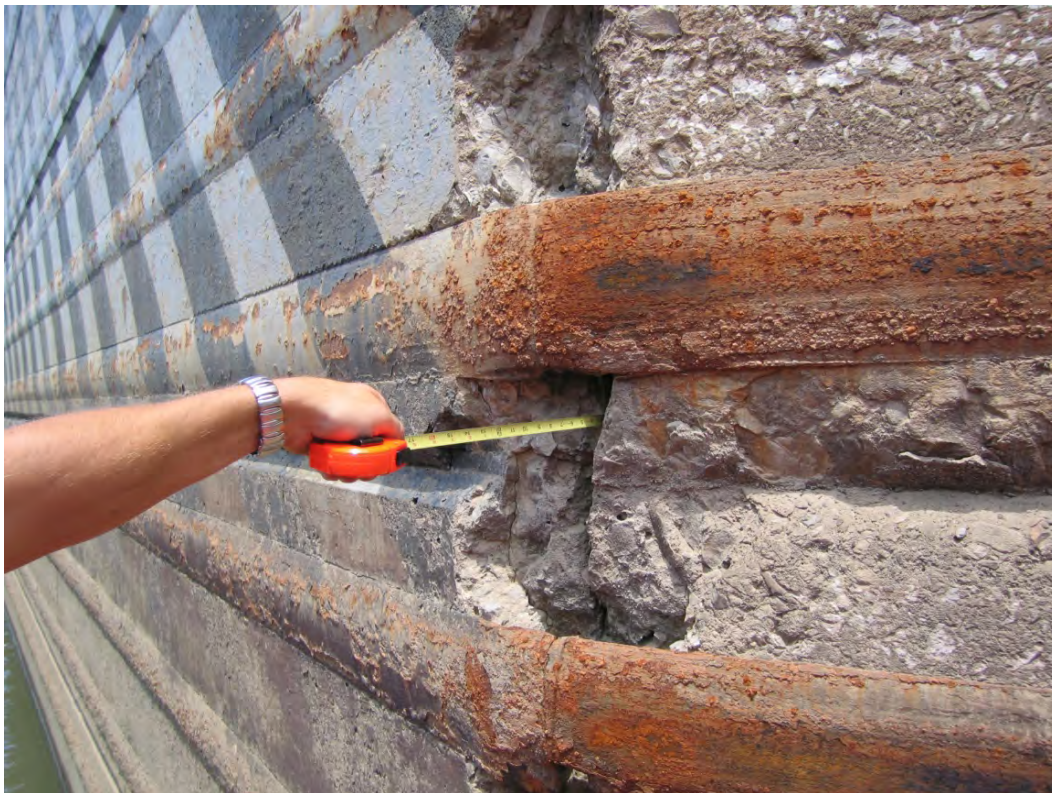
An example of the severity of the damage to the concrete at the lower land-wall approach vertical joint that required repair is shown in the close-up photograph of Figure 50. The contractor was directed to saw-cut and chisel to remove damaged concrete to a depth of at least 2 in. or to sound concrete. The cavity shown in Figure 50 is approximately 12 in. deep. The lateral extent of the concrete removal would be only 12 in. on each side of this vertical joint, as contrasted with 36 in. and 48 in. on either side of the upper land-wall approach vertical joint. To accommodate the repair wall armor steel plates, the contractor would be required to cut 12.5-in.-long by 2-in.-high notches in the existing wall armor rub strips. The repair steel plates would be fully welded to the existing wall armor rub strips, as well as attached to the concrete walls by anchor rods. Figure 51 shows template markings for removal of the damaged concrete prior to the installation of the repair steel plates.

Figure 50. Closeup photo of major concrete damage at the vertical joint to be repaired.
